Building Inspection Report

Partial Sample Report

Anywhere, Idaho

Inspection Date:
12/28/2005

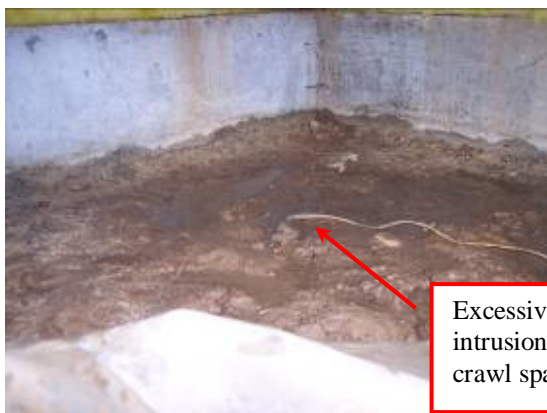
- **#2-Improve:** All wood debris and/or trash should be removed from the crawl space. Organic debris around a property increases risk of insect or rot damage.
- **#3-Repair:** Standing water was observed in the crawl space. Wet crawl spaces risk building damage from rot and insects and can cause interior mold or mildew. This can easily be remedied with a few roof and lot drainage adjustments. Roof and lot drainage repairs or improvements should be addressed as a first step to controlling water in the crawl space (see "Exterior and Roofing Sections"). This condition should then be monitored to determine if additional measures are necessary.

Excessive water intrusion in the crawl space.

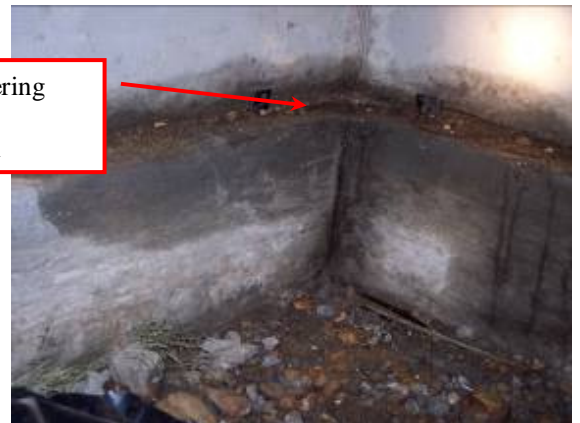
Water entering thru the foundation

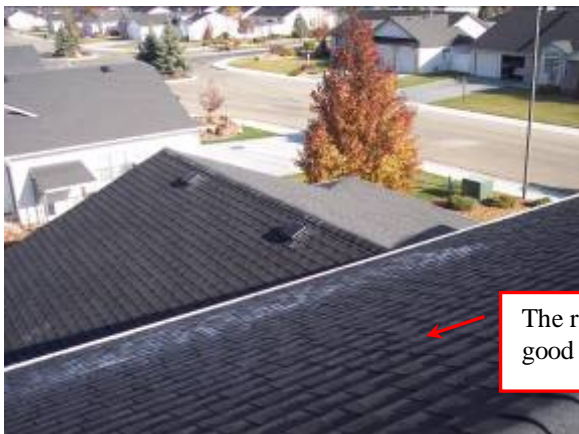
The roof is in good condition

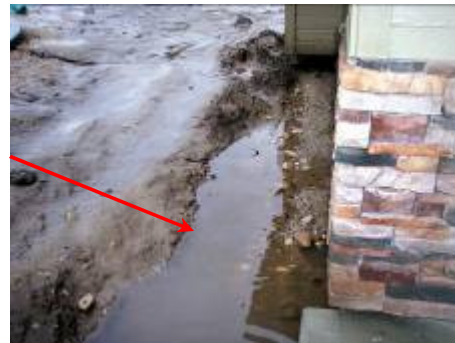
- **#1- Concern, Repair:** The grading should be improved to promote the flow of storm water away from the house. This is a potential source of the water intrusion in the crawlspace. This can often be easily accomplished by the addition of top soil. The ground should slope away from the house at a rate of one inch per foot for at least the first five feet. At least six (6) inches of clearance should be maintained between soil level and the bottom of exterior wall siding.

Grading improvement needed to prevent water intrusion

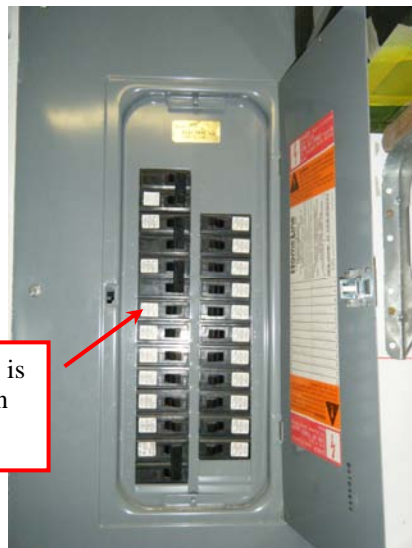
The electrical panel is well arranged and in good order

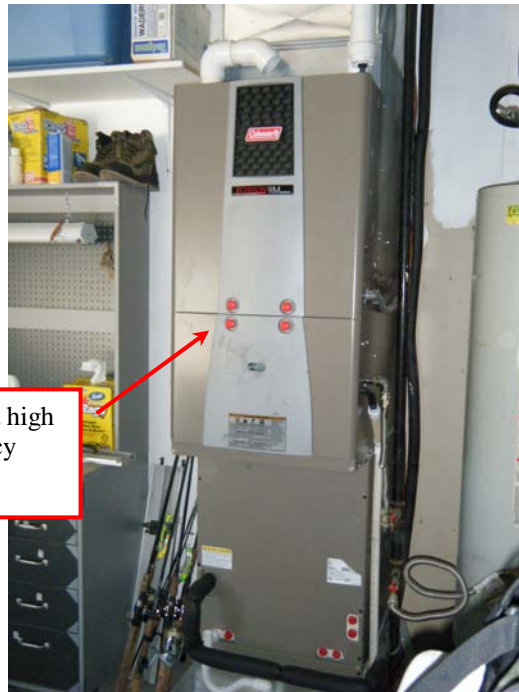
- **#1-Repair:** The furnace is dirty and requires cleaning and service. This should be a regular maintenance item to assure safe, reliable heat.

This is a high efficiency furnace

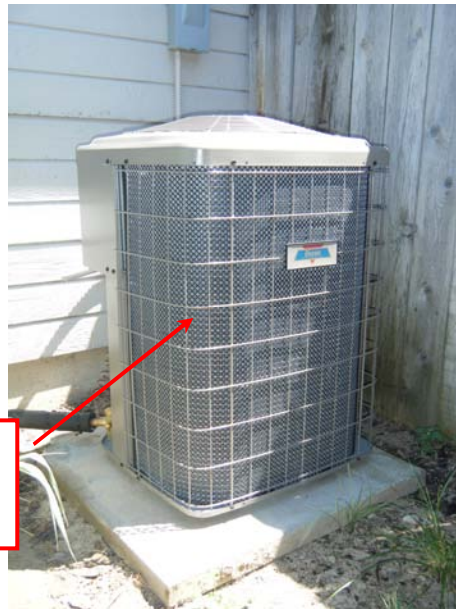
The air conditioning unit is in good condition.

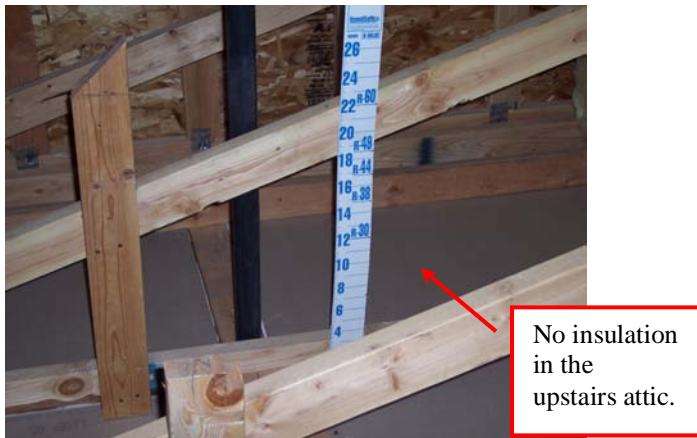
- **#2-Repair:** No insulation has been installed in the attic. Contact the building contractor for repairs.
